**ALABAMA HAZARDOUS WASTES MANAGEMENT AND MINIMIZATION ACT (AHWMMA)  
COMPLIANCE EVALUATION INSPECTION (CEI) REPORT**

Aerospace Coatings International, LLC (ACI)  
370 Knight Drive  
Oxford (Talladega County), AL 36203

June 25, 2019

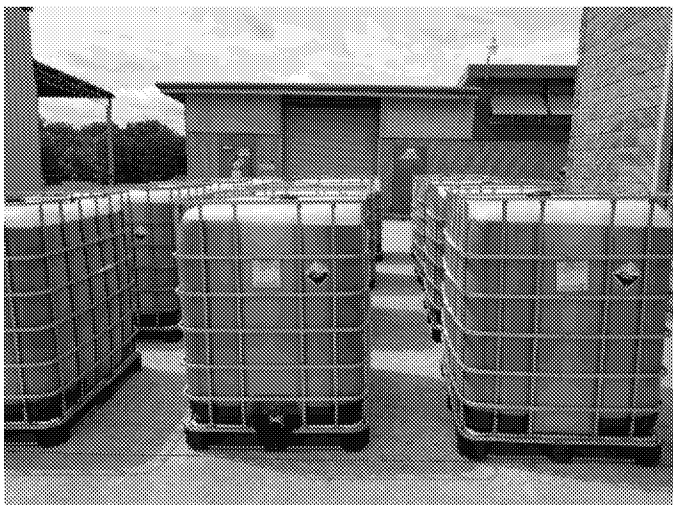
Mr. Landingham first escorted us outside, to a concrete lot located between the main building (to the west), the LG building (to the east), and the stripper building (to the south). Thirteen plastic 330-gallon totes containing waste chromic acid were staged on the lot at the time of the inspection. All thirteen containers were closed, labeled with the words "Hazardous Waste", labeled with the appropriate waste codes (D002 and D007), labeled with a "Corrosive" placard, and marked with an accumulation start date of "6-25-19"

Photograph #1: containers of hazardous waste staged outside the CAA

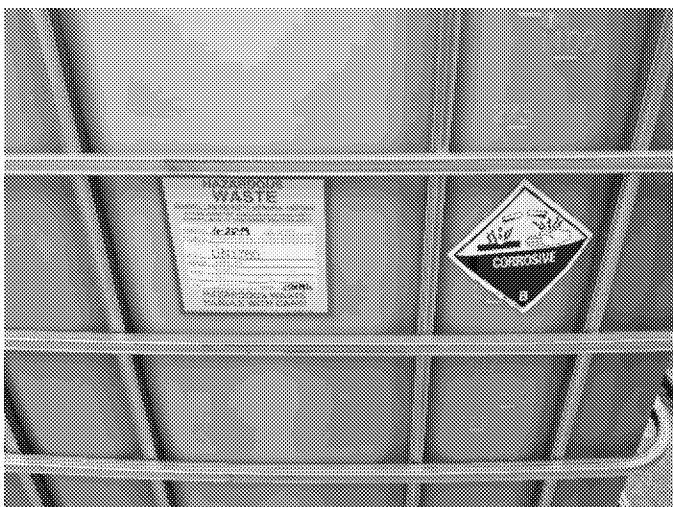
Photograph #2: label on a container of hazardous waste staged outside the CAA

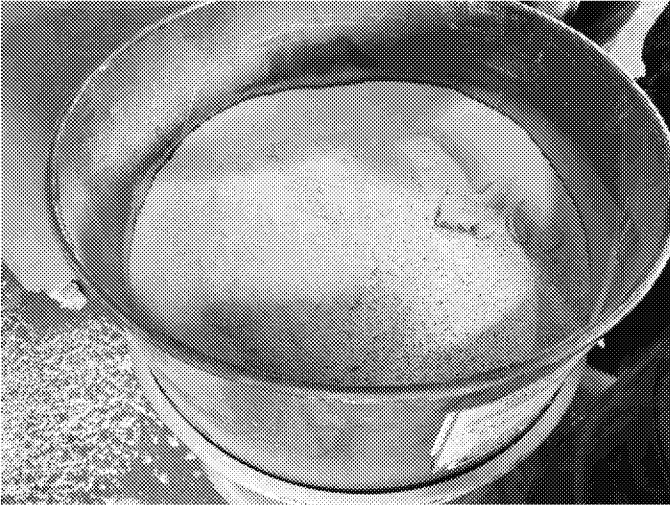
Mr. Landingham next escorted us to the facility’s multi-purpose plating line—an enclosed room located on the south side of the main building. A blasting cabinet was staged in the hallway outside of the multi-purpose plating line. According to Mr. Landingham, parts containing cadmium are blasted in this cabinet. Two satellite accumulation containers (open-top metal 55-gallon drums holding spent blast media, filters, and PPE) were staged next to the blasting cabinet. Both drums were open (their lids were not secured) and labeled with the words “Hazardous Waste” and “D006” (see Photograph #7 and Photograph #8). The total amount of waste accumulated in this area appeared to be greater than 55 gallons. Spent blast media was observed on the floor around the drums.

Photograph #7: open satellite accumulation container staged outside the multi-purpose plating line

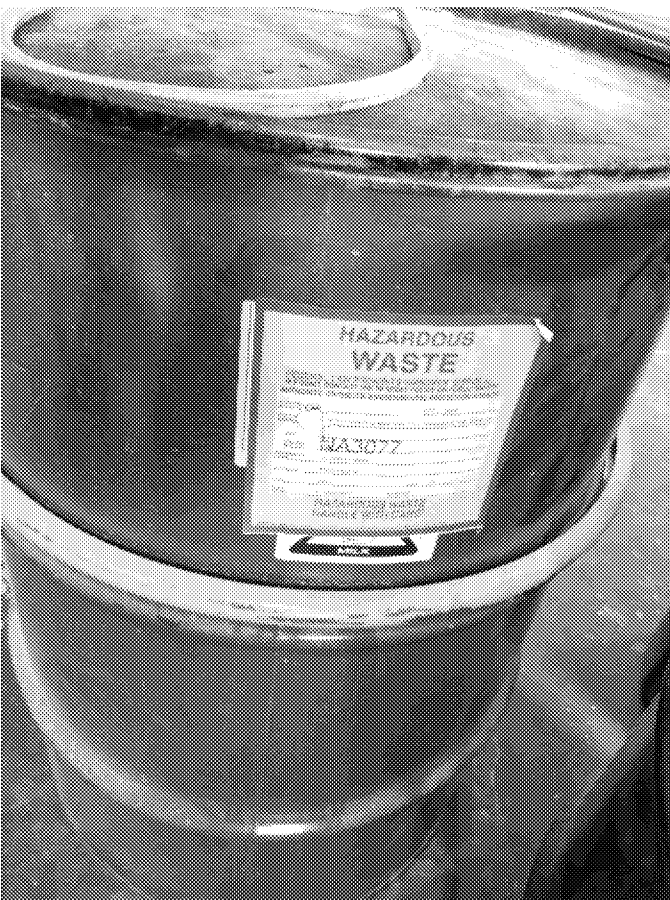
Photograph #8: open satellite accumulation container staged outside the multi-purpose plating line

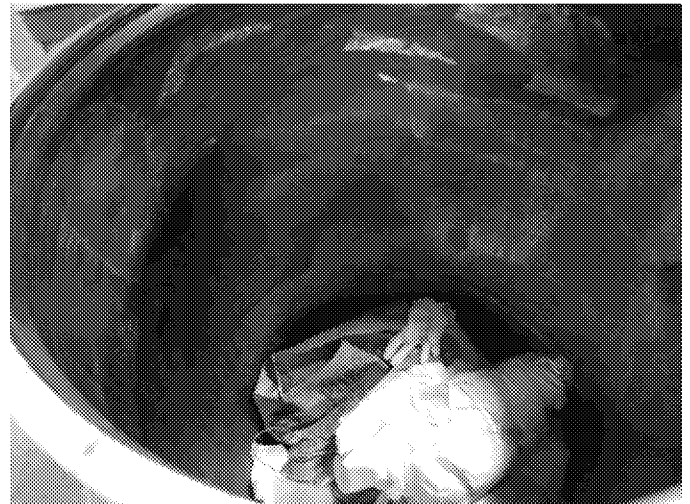
The multi-purpose plating line includes a series of small plating baths used to apply a variety of coatings (including black oxide, cadmium, chromium, copper, magnesium phosphate, nickel, silver, and zinc) to small airplane parts. These baths were equipped with secondary containment (some were staged on plastic spill control pallets, some were staged within plastic basins, and some were surrounded by concrete berms). Liquids were observed in the secondary containment structures of several of the baths. One open-top plastic 55-gallon drum containing nickel-contaminated PPE was staged in a corner of the room. The container was open (the lid was not secured) and labeled with the words “Non-Hazardous Waste” (see Photograph #9). One satellite accumulation container (an open-top plastic 55-gallon drum holding chromium-contaminated PPE) was staged on the opposite side of the room. The container was open (its lid was not secured) and labeled with the words “Hazardous Waste”, “D003”, and “F007” (see Photograph #10 and Photograph #11).

Photograph #10: open satellite accumulation container in the multi-purpose plating line

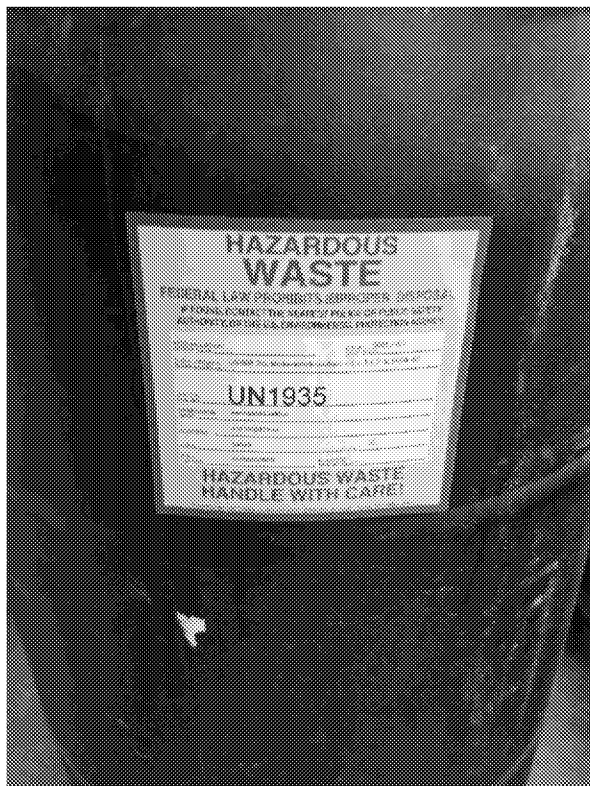
Photograph #11: open satellite accumulation container in the multi-purpose plating line

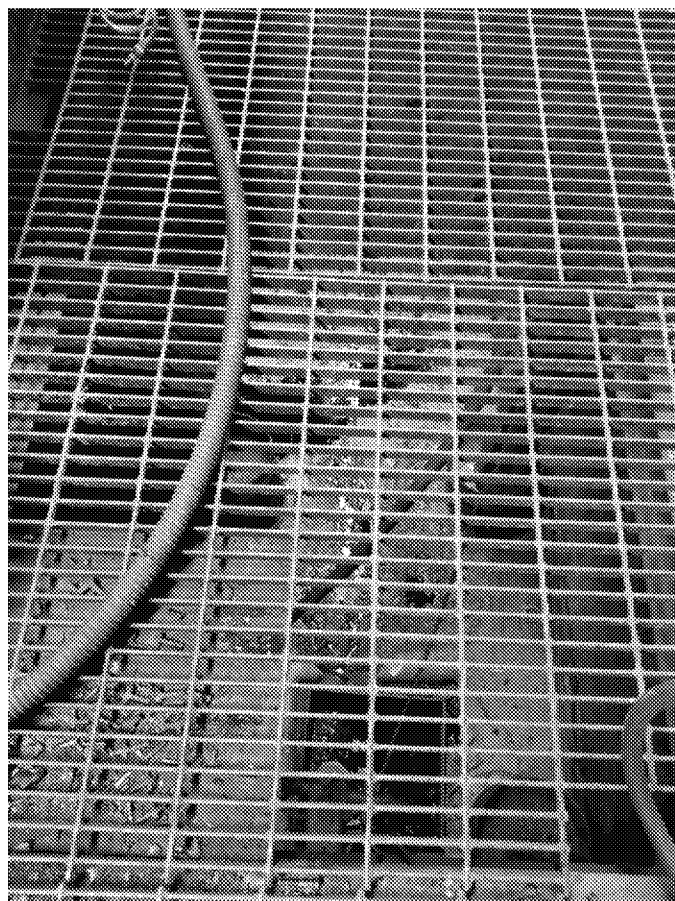
Photograph #14: sump in the floor underneath the chrome plating line (contained liquid at the time of the inspection)

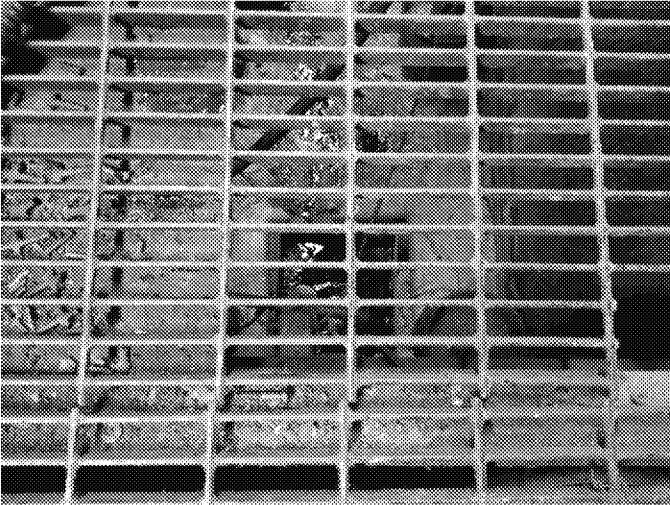
Photograph #15: sump in the floor underneath the chrome plating line (contained liquid at the time of the inspection)

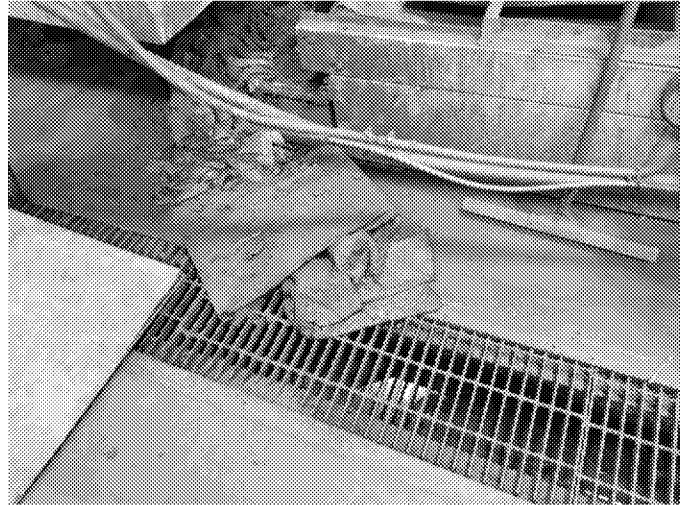
Photograph #21: trough in the floor of the OD shop (contained liquid at the time of the inspection)

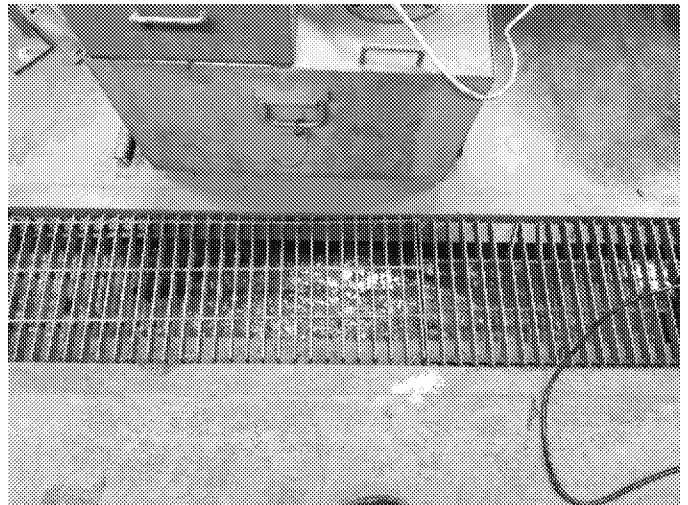
Photograph #22: trough in the floor of the OD shop (contained liquid at the time of the inspection)

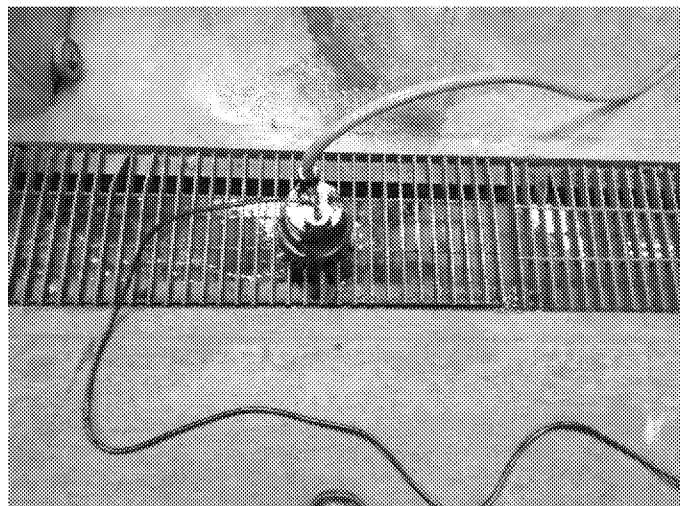
Photograph #23: trough in the floor of the OD shop (liquid being pumped into a 330-gallon tote)

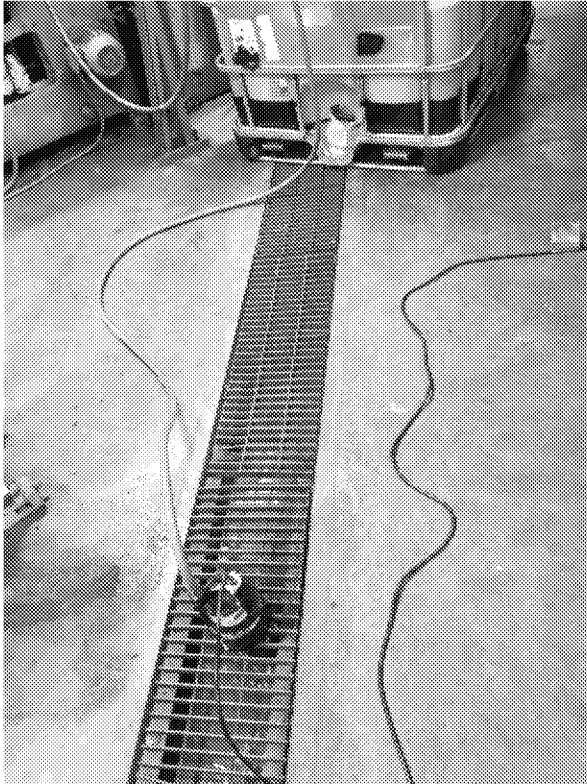
Photograph #24: trough in the floor of the OD shop  
(liquid being pumped into a 330-gallon tote)

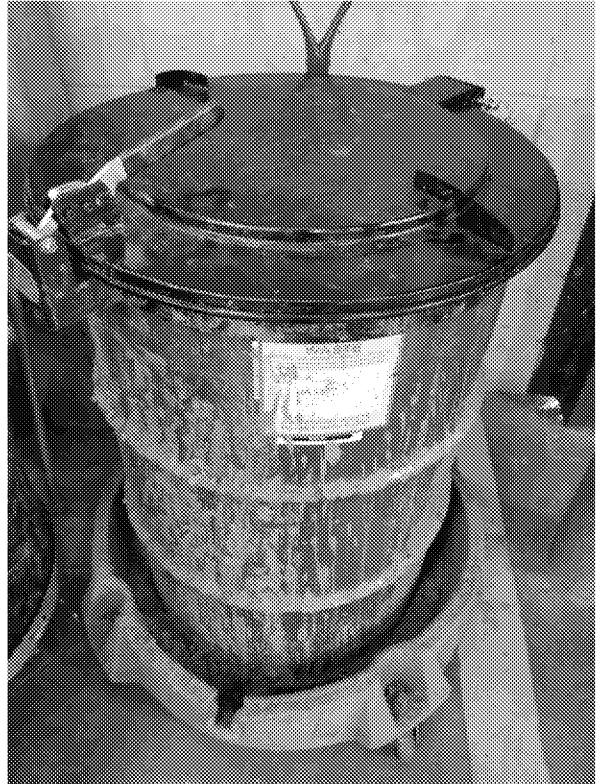
Photograph #26: satellite accumulation container in the  
OD shop (waste on side of drum)

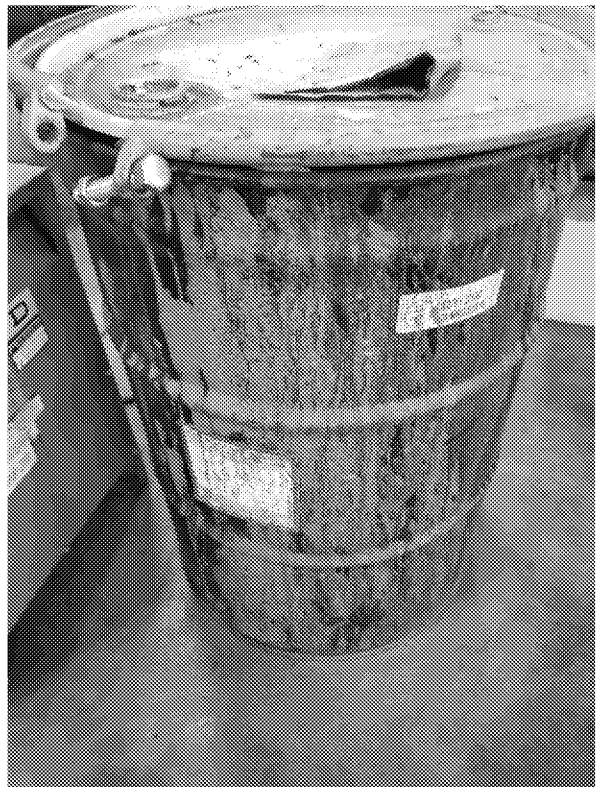
Photograph #27: open satellite accumulation container in  
the OD shop (waste on side of drum)

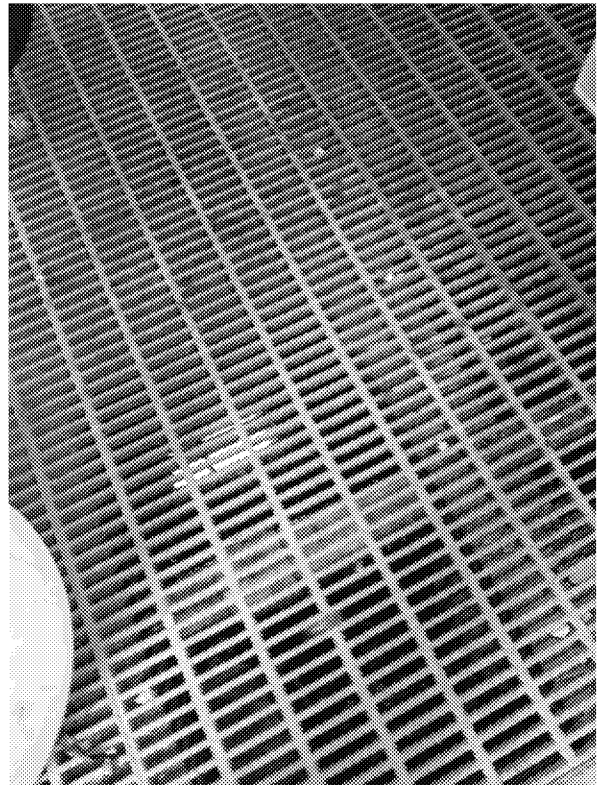
Photograph #31: pit in the floor underneath the stripper shop (contained liquid at the time of the inspection)

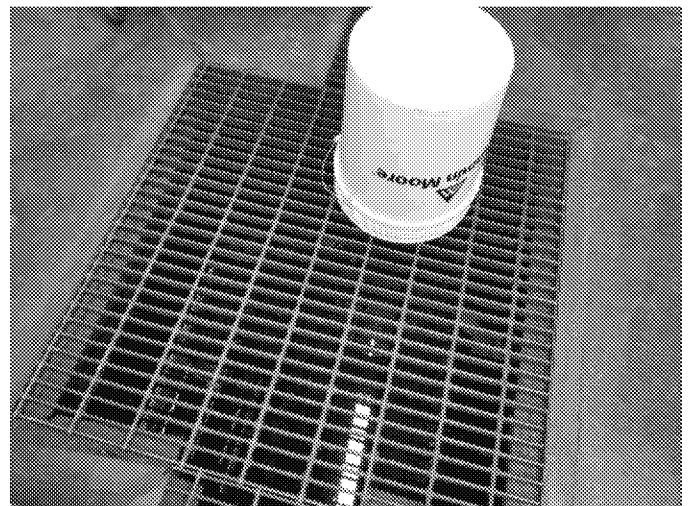
Photograph #36: trough in the floor of the ID shop (contained liquid at the time of the inspection)

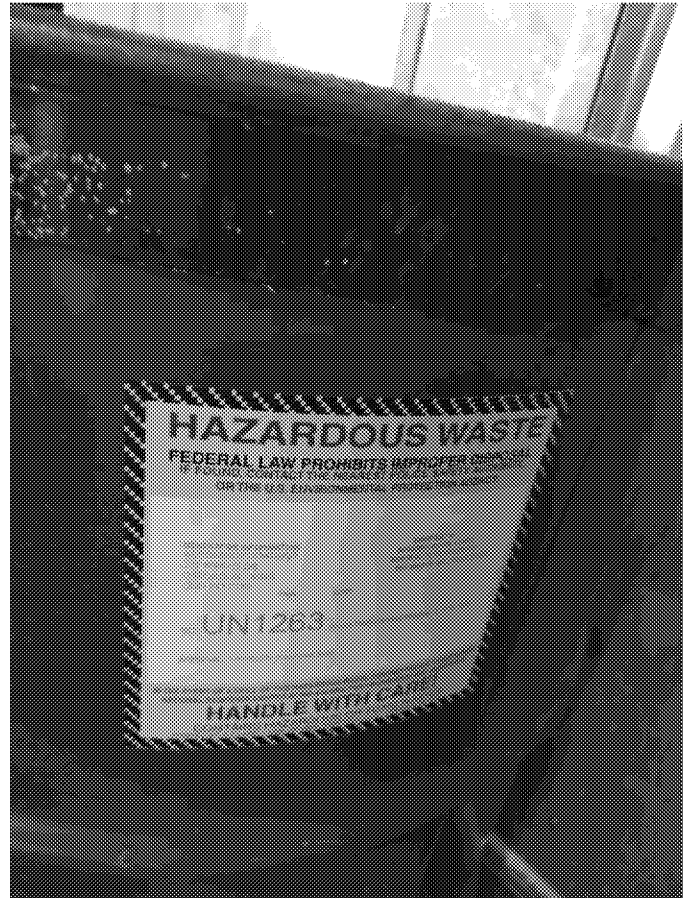
Photograph #39: open satellite accumulation container in the ID shop (inside the paint booth)

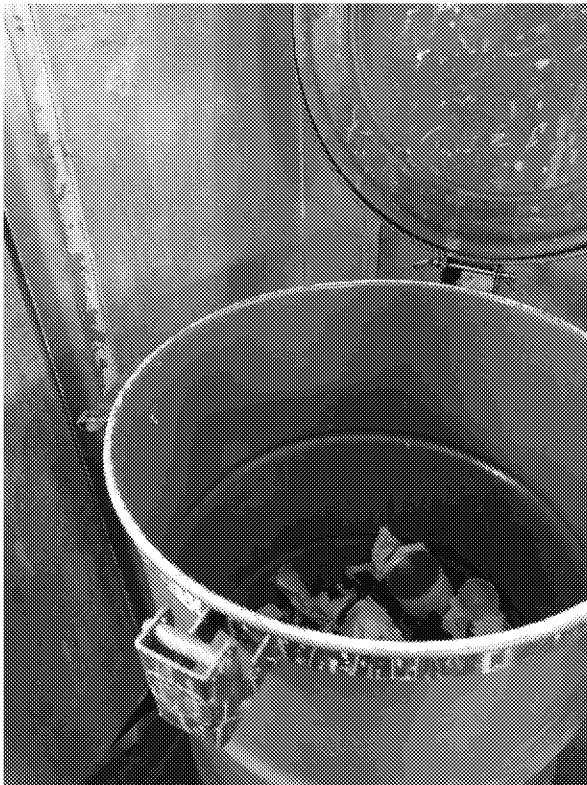
Photograph #38: open satellite accumulation container in the ID shop (inside the paint booth)

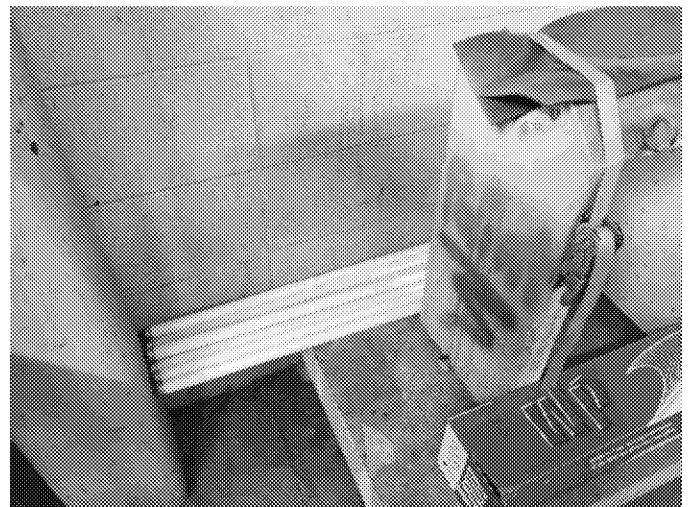
A totally enclosed negative-pressure paint booth was located in a corner of the ID Shop. One satellite accumulation container (an open-top metal 55-gallon drum holding paint-related wastes) was staged in the paint booth at the time of the inspection. The container was open (its lid was not secured) and labeled with the words “Hazardous Waste”, “D001”, and “D035” (see Photograph #38 and Photograph #39). Seven universal waste lamps were staged on a rolling cart outside of the paint booth (see Photograph #40). These lamps were not labeled and had not been placed in a container.

Photograph #40: uncontained, unlabeled universal waste lamps in the ID shop

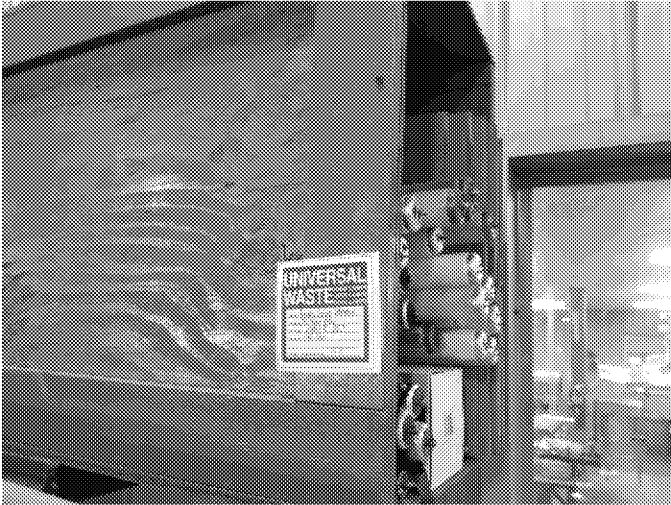
Photograph #41: open container of universal waste lamps in the maintenance area

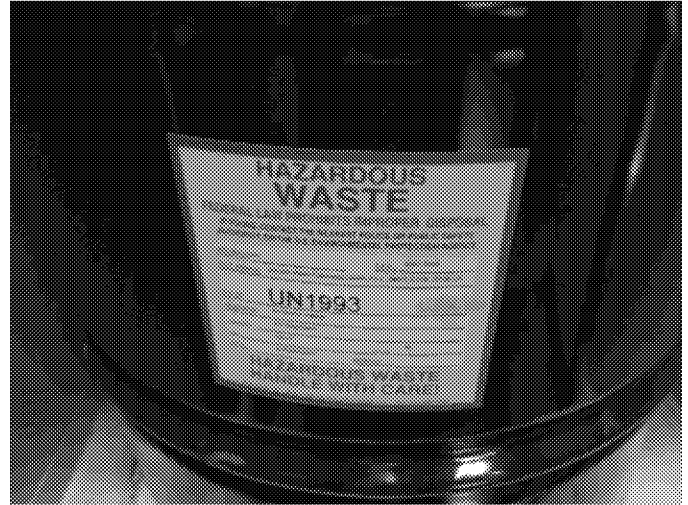
Mr. Landingham next escorted us to the Plasma™ coating area—an enclosed room located next to the honing shop where Plasma™ coating (a high-zinc metallic powder) is applied to parts as necessary. The Plasma™ coating area houses two totally enclosed negative-pressure spray booths where robotic arms apply Plasma™ coating to parts using a high-velocity flame spray system. One wash stand containing new MEK was staged in this area. One satellite accumulation container (a closed-top metal 55-gallon drum holding used MEK) was staged within a metal cabinet located outside of the Plasma™ coating area. The container was open (a funnel had been placed in the drum's bung hole) and labeled with the words "Hazardous Waste", "D001", and "D035" (see Photograph #42 and Photograph #43).

Photograph #43: open satellite accumulation container staged outside of the Plasma™ coating area

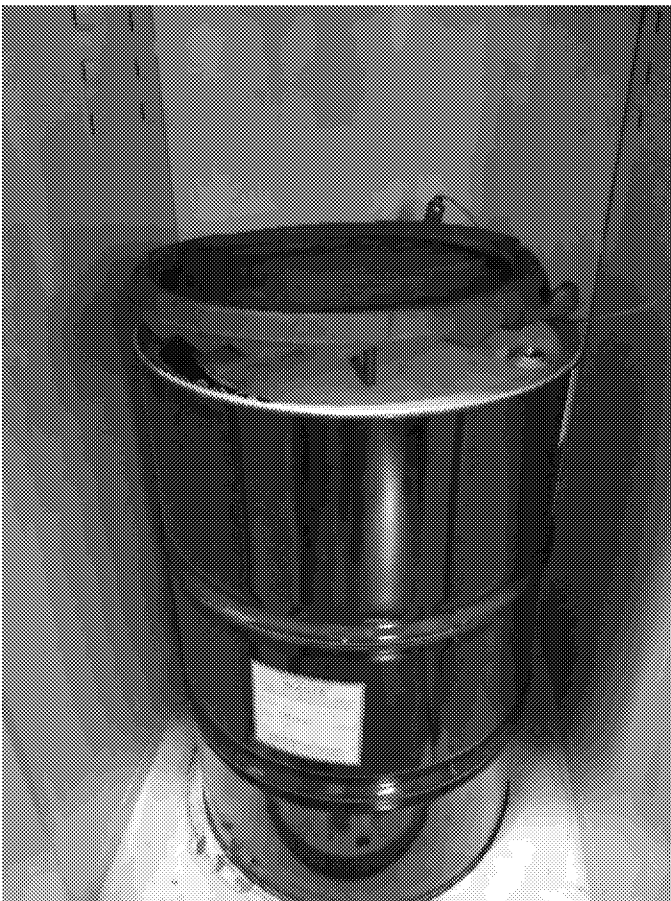
Photograph #42: open satellite accumulation container staged outside of the Plasma™ coating area

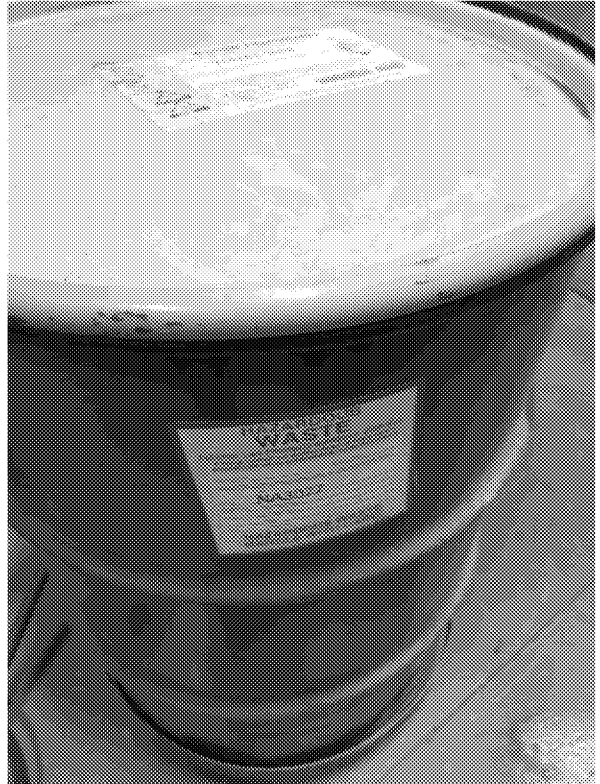
Photograph #47: open satellite accumulation container in the LG building preparation area

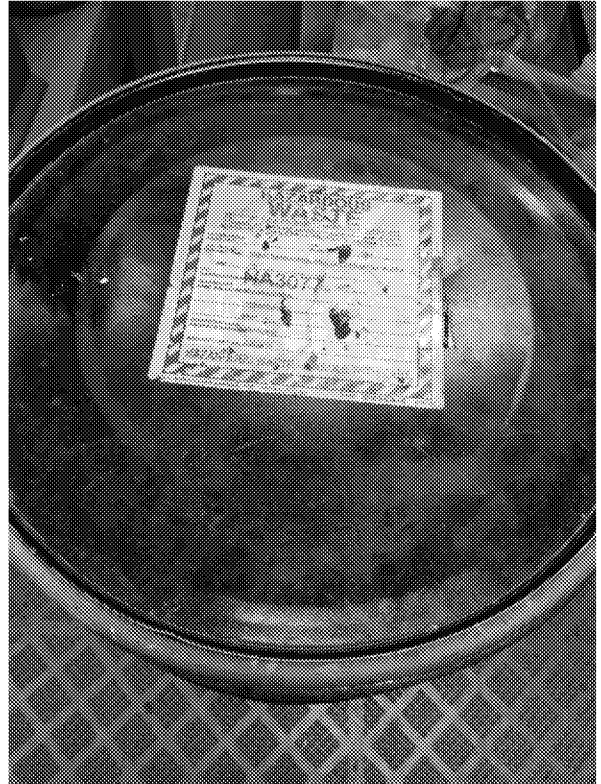
Photograph #55: open satellite accumulation container in the QA/QC laboratory

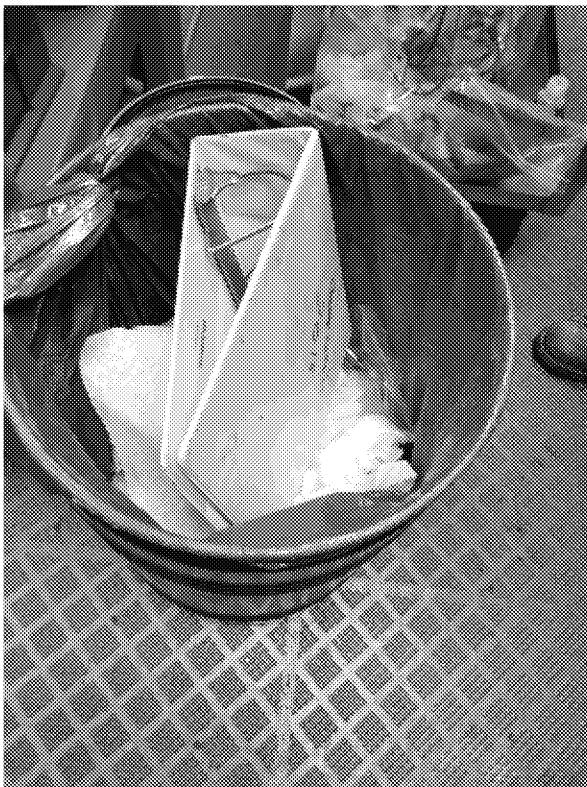
Photograph #54: open satellite accumulation container in the QA/QC laboratory

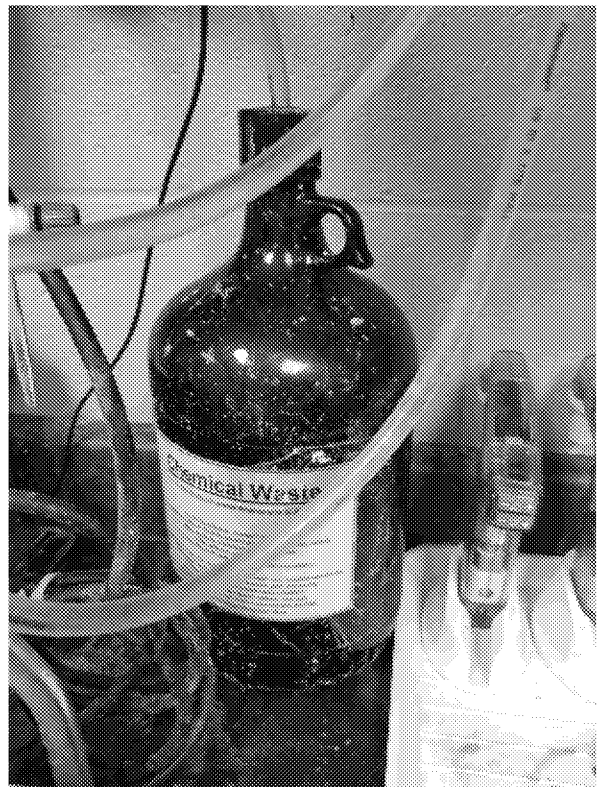
Photograph #56: improperly labeled satellite accumulation container in the QA/QC laboratory
